Erroneous measurement of haemodynamic parameters by PiCCO™ monitor in a critically ill patient with renal replacement therapy: a case report

Critical Care 2006, **10**:410 (doi:10.1186/cc4911)

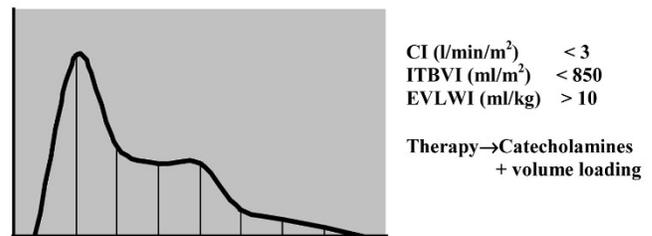
In Figure 1 we can see how the area under the curve had a different morphology to the curve of Figure 2. The first curve had a plateau in the middle descendent line (Figure 1). Its risen curve caused an erroneous measurement of the haemodynamic parameters by the PiCCO™ monitor, with a smaller calculated cardiac output.

Calibration with continuous venous-venous haemodialysis.

We think that the alteration of the area under the curve was produced by the turbulent flow from the haemodialysis catheter. The turbulent flow decreases the velocity of the cold saline bolus in the vein. The area under the curve is larger because the cold saline needs more time to arrive at the thermometer through the long arterial line. Due to the high flow in the vein, there was an alteration of the area under the curve obtained by the injection of cool saline. We think the same alteration would be produced by any catheter, if calibration is done during haemodialysis, with a working pump. PiCCO™ calibration during haemodialysis through a central vein catheter may therefore produce erroneous measurements.

Based on these findings we recommend stopping CVVH-D during the calibration of the PiCCO™ monitor.

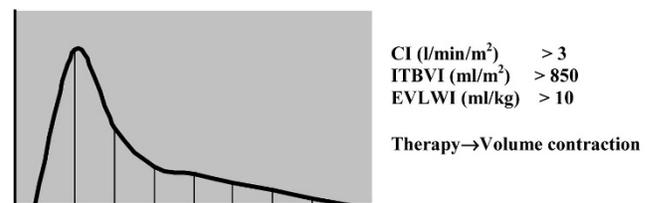
Figure 2

The clinical condition of the patient worsened so we performed echocardiography, which showed us a completely different clinical picture (hyperdynamic and hypovolemic state) compared with the PiCCO™ monitor results. The CVVH-D blood pump was stopped and a new calibration was performed (Figure 2). The newly obtained PiCCO™

measurements showed a different physiology and treatment (Figure 2), similar to that obtained by the echocardiogram.

Calibration without continuous venous-venous haemodialysis.

The CVVH-D pump must be stopped during the calibration.
